# febiEXAKT

## Triangular control arm

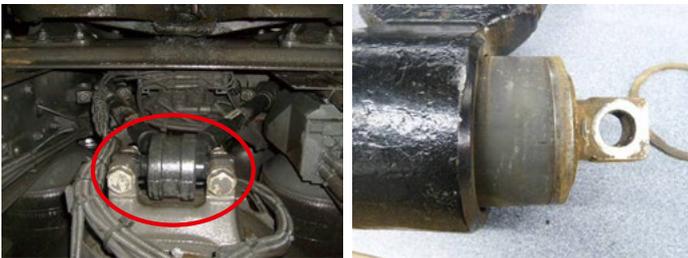
Premature failure of the triangular control arms central bearing.

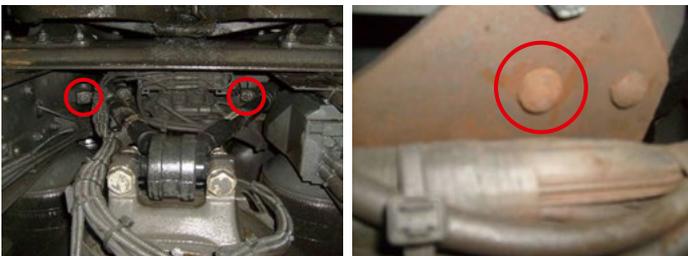
Both bearing mounting brackets which link the triangular control arm to the chassis are joined to the chassis via mounting plates. The mounting plates are attached to the frame with rivets. The components referred to are subject to significant stress during loading and unloading and this applies even more if the truck is overloaded or road conditions are poor.

These loads can lead to the rivets working free. The bearing mounting bracket which is joined directly to the triangular control arm may exhibit play due to the lost rivets. Even a minimum amount of play is enough to transfer additional forces to the central bearing. The central bearing, however, cannot withstand these unforeseen loads and fails as a result of the additional stress.

Check the mounting plates before fitting a new triangular control arm. If a rivet has been lost, it can be replaced with a screw. This screw is sufficient to minimise the play and the central bearing will again be subjected only to the forces for which it was intended. febi bilstein recommends the use of febi 26709/26710 threadlocker for maximum hold. The liquid plastic which cures in the absence of air prevents re-release or loosening of the threaded joint between screw and frame even under the most severe operating conditions.
