febiEXAKT

Protection cap for Scania vehicles

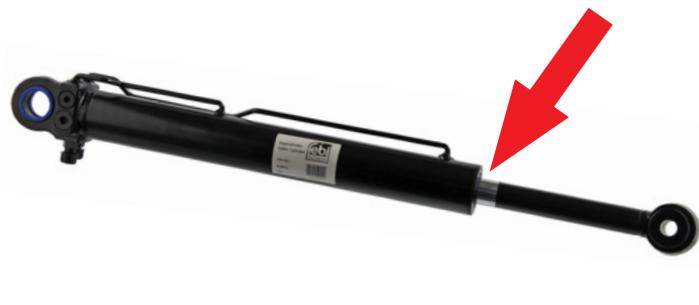
Leaks in the seal ring of the cabin tilt cylinder on the piston rod (Figure 1) occurred on Scania vehicles. In addition, there were some cases of heavily contaminated hydraulic system.

The cause of the leak in the seal ring is damage to the piston rod (Figure 2) through dirt and grime in conjunction with water spray. Thus, the sealing ring is leaking, which on the one hand leads to the loss of hydraulic oil and on the other hand can also penetrate dirt and moisture in the tilt cylinder (Figure 3) and thus contaminates the entire cabin tilt hydraulic system.

febi bilstein is now delivering a protective cap (Figure 4) with the above-mentioned references. Mounting the protective cap prevents dirt and splash water coming directly to the seal. Thus, the service life of the tilting cylinder and the other components of the cabin tilt hydraulic system is extended considerably.
