Torque Arm for Fan Clutch

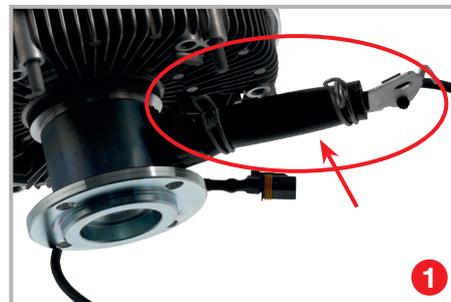
Due to age related wear the torque arm (Fig. 1) should be replaced at the same time as the clutch. An old torque arm would be susceptible to material fatigue, if the torque arm fails the connection cable is placed under unacceptable stress.

The sleeve, in which the cable is mounted, is the only component that does not rotate during operation. If the torque arm fails, the sleeve is prevented from rotating only by the cable, which will lead to a rupture of the cable. In case of a short circuit of the blank cables, the engine control unit could be damaged.
