## HP102 – HP1572 Technical Information

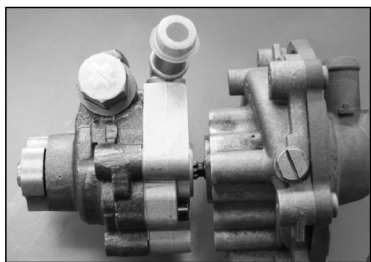
Figure 1

The HP102 and HP1572 have a splined shaft at the rear of the pump. This is used to drive the water pump which is connected directly to the unit. (figure 1)

Care must be taken when connecting the two units. If excessive force is used this will alter the position of the splined shaft and so the pulley hub. The unit will malfunction if this occurs.

We recommend that the securing bolts are tightened in sequence, a small amount each time until the unit is fixed. At no point should either unit be impacted.
