ATTENTION WITH TENSOR AT THE TIME OF ADJUSTMENT - ENGINE RENAULT / PEUGEOT TIMING BELT- CT1045

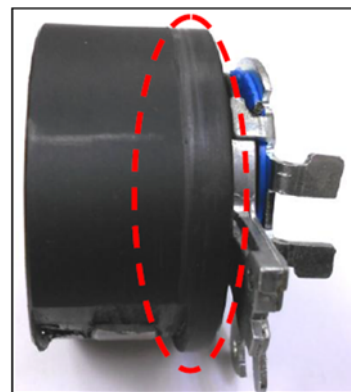
Fig. 1

Wear on the tensioner.

Incorrect tensioning (clockwise) causes the pulley contact with the head.

Properly tension the tensioner counter-clockwise.
