## TECH NOTE

# TIMING BELT TRACKING ISSUES ON RENAULT ENGINES

BULLETIN: TSB010\_AU

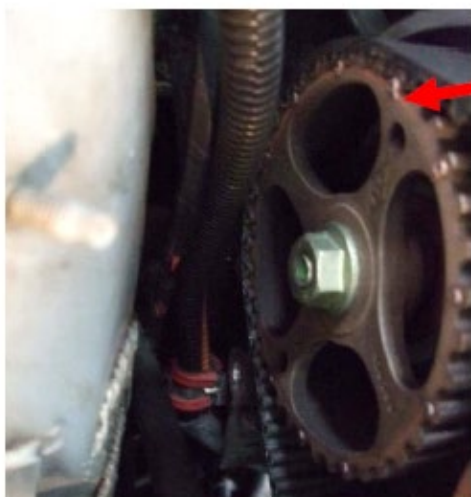
Fig. 1

The timing belt tracks heavily toward the front of the engine which can cause the camshaft pulley flanges to detach and possibly enter the drive system (Fig. 1 shows a detached camshaft flange). This can result in timing system damage and complete timing belt failure.

This failure mode originates from excessive movement of a worn or faulty water pump bearing.

Flange  
detached

To prevent this failure, it is recommended that the water pump is replaced at the same time as the timing belt, even if the Water Pump is not showing visible signs of fatigue.

In the event of the camshaft pulley becoming loose or detached, Gates recommends that an OEM replacement is sourced.

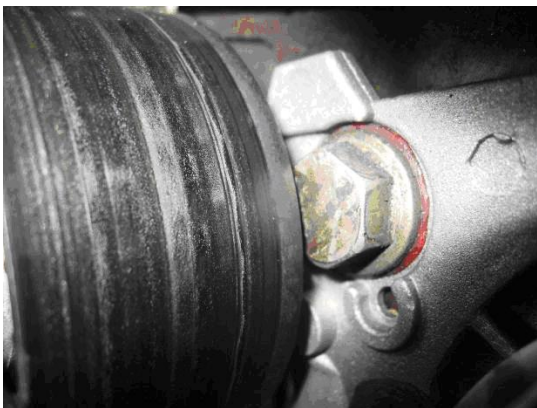
**Fig.2**

**Fig. 2 shows the extremely limited space between the water pump bolt and tensioner pulley.**

**There is very little room for error here.**

1. While changing the water pump, ensure the original correct OEM bolts/washers are reused and torqued correctly to ensure clearance between the pulley and bolt head is maintained.

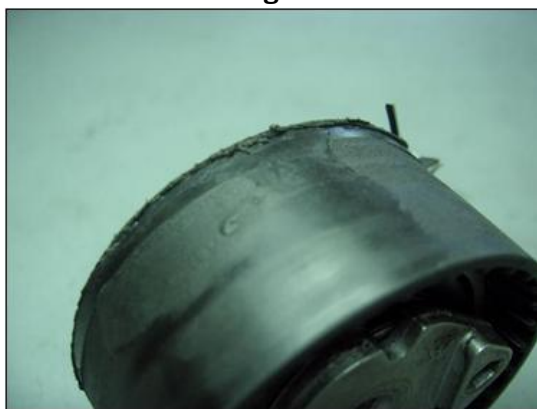
**Fig.3**

**Fig. 3 shows the result of pulley contact due to an incorrect aftermarket bolt being installed or a bolt coming loose.**

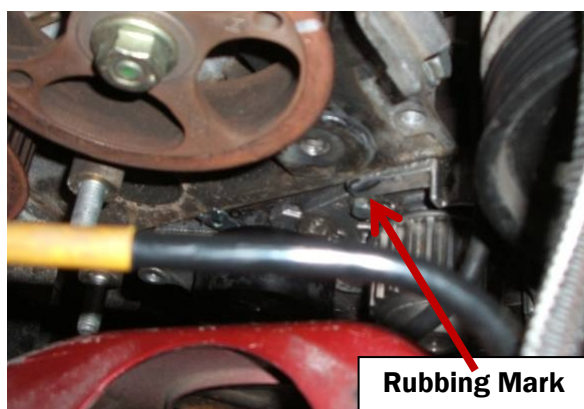
**Fig.4**

2. When installing the new timing idler pulley, ensure that the spacer (sitting between the old pulley and the engine block) is re-fitted between the new pulley and the engine block. If not, the idler pulley can touch the water pump, causing idler and belt failure (Fig. 4 and 5).

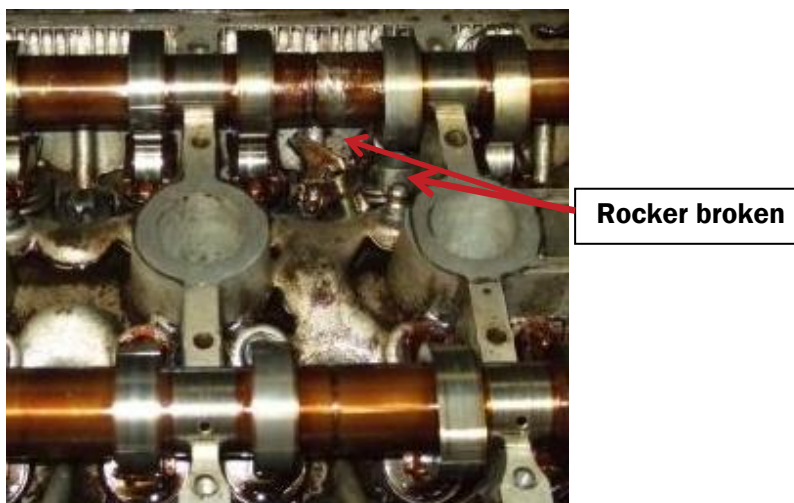
**Fig. 7**

If timing system failure and piston to valve contact has occurred, close inspection of the camshaft rocker assembly is essential. Breakage of the rocker arms is possible and replacement is necessary, Fig. 7 shows a broken rocker.
