AUTOELECTRO

STARTER MOTORS & ALTERNATORS

IMPORTANT PLEASE READ THE INFORMATION BELOW BEFORE FITTING THIS PART AS THERE ARE KNOWN ISSUES WHICH WILL RESULT IN THE PREMATURE FAILURE OF THE UNIT AND MAY INVALIDATE YOUR WARRANTY

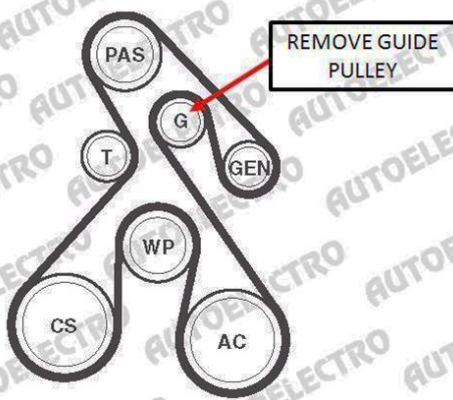
ORIGINAL BELT ROUTING

The vehicle to which this alternator is fitted has a known fault which results in the premature failure of the clutch pulley and/or bearings. The premature failure can be caused due to excessive load being exerted to the alternator pulley and bearings.
