# AUTOELECTRO

## STARTER MOTORS & ALTERNATORS

**IMPORTANT PLEASE READ THE INFORMATION BELOW BEFORE FITTING THIS PART AS THERE ARE KNOWN ISSUES WHICH WILL RESULT IN THE PREMATURE FAILURE OF THE UNIT AND MAY INVALIDATE YOUR WARRANTY**

Mini R50/R52/R53 1.6 & 1.4 Petrol 2001-2009. All vehicles with W10 engine code are affected from 2003 onwards.

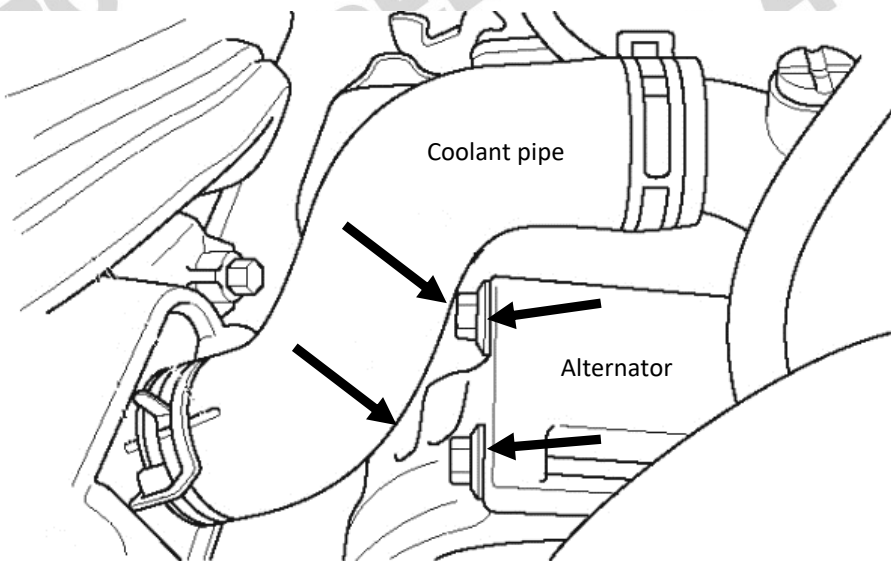
Alternators fitted to the above vehicle are being returned under warranty after replacement due to the drive belt slipping. Upon inspection there were signs of engine coolant on the drive bracket.

We have found that there is a coolant pipe which runs directly above the alternator and across the mounting brackets. When the original alternator has been removed the pipe has not been detached or moved into a safe position, perhaps to save time. By doing this the pipe chafes against the alternator mounting bolts causing leakage of coolant on to the alternator and the drive belt. This results in the drive belt slipping causing a charging fault/low charge rate.

In all cases when replacing the alternator on this vehicle the fitter must ensure that the pipe is clear from the mounting bolts when removing the alternator. If the pipe has been damaged it **must** be replaced
