febiEXAKT

Knuckle assembly for ABS

febi no. 19100

to fit
Mercedes-Benz

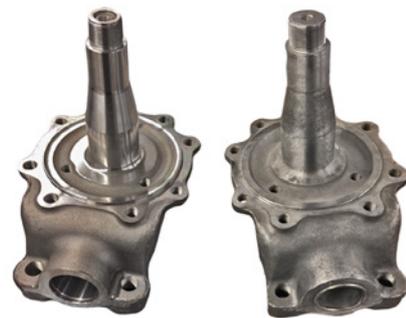
The ABS ring brushes against the knuckle assembly at the height of the ABS sensor. If the material wear of the ring is at an advanced stage, the sensor cannot measure the ABS signal properly any more.

In the first version, the distance that the OE had envisaged between the knuckle assembly and the ABS ring was too small. Therefore, the ABS ring used to brush against the knuckle assembly during movement of the vehicle.

febi no. 19100

febi no. 81555

febi bilstein offers the new version machined in its in-house facilities, under the febi number 19100. As an alternative for vehicles without an ABS system, the old version of the knuckle assembly will continue to be offered under the febi special number 81555.
