AUTOELECTRO

STARTER MOTORS & ALTERNATORS

IMPORTANT PLEASE READ THE INFORMATION BELOW BEFORE FITTING THIS PART AS THERE ARE KNOWN ISSUES WHICH WILL RESULT IN THE PREMATURE FAILURE OF THE UNIT AND MAY INVALIDATE YOUR WARRANTY

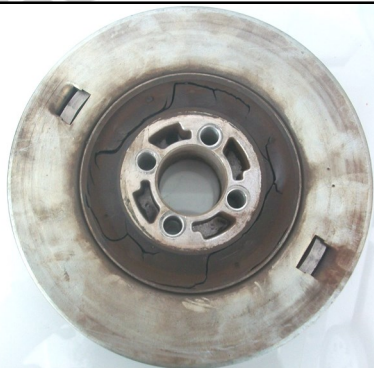
Picture of a **WORN** TVD (Torsional Vibration Damper or 'bottom pulley')

As it can be seen the TVD has started to crack and break away from its mounting point

Since the TVD turns at engine speed, a worn TVD can cause vibration rather than acting as a vibration damper. The vibration of the belt between the pulleys will result in belt wear and add stress/strain on the tensioner and the other pulleys and ancillaries including the alternator pulley, thus causing premature failure of the alternator clutch pulley.

If in doubt, replace the TVD. Alternator failure due to worn TVD WILL invalidate the warranty

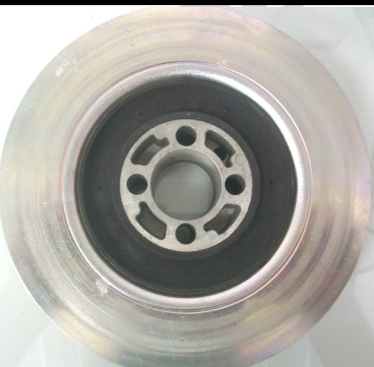
Picture of a new TVD. The dampening insert is in one piece with no cracks or imperfections.
