## LuK GearBOX, Part number: 462 0205 10

## SCHAEFFLER

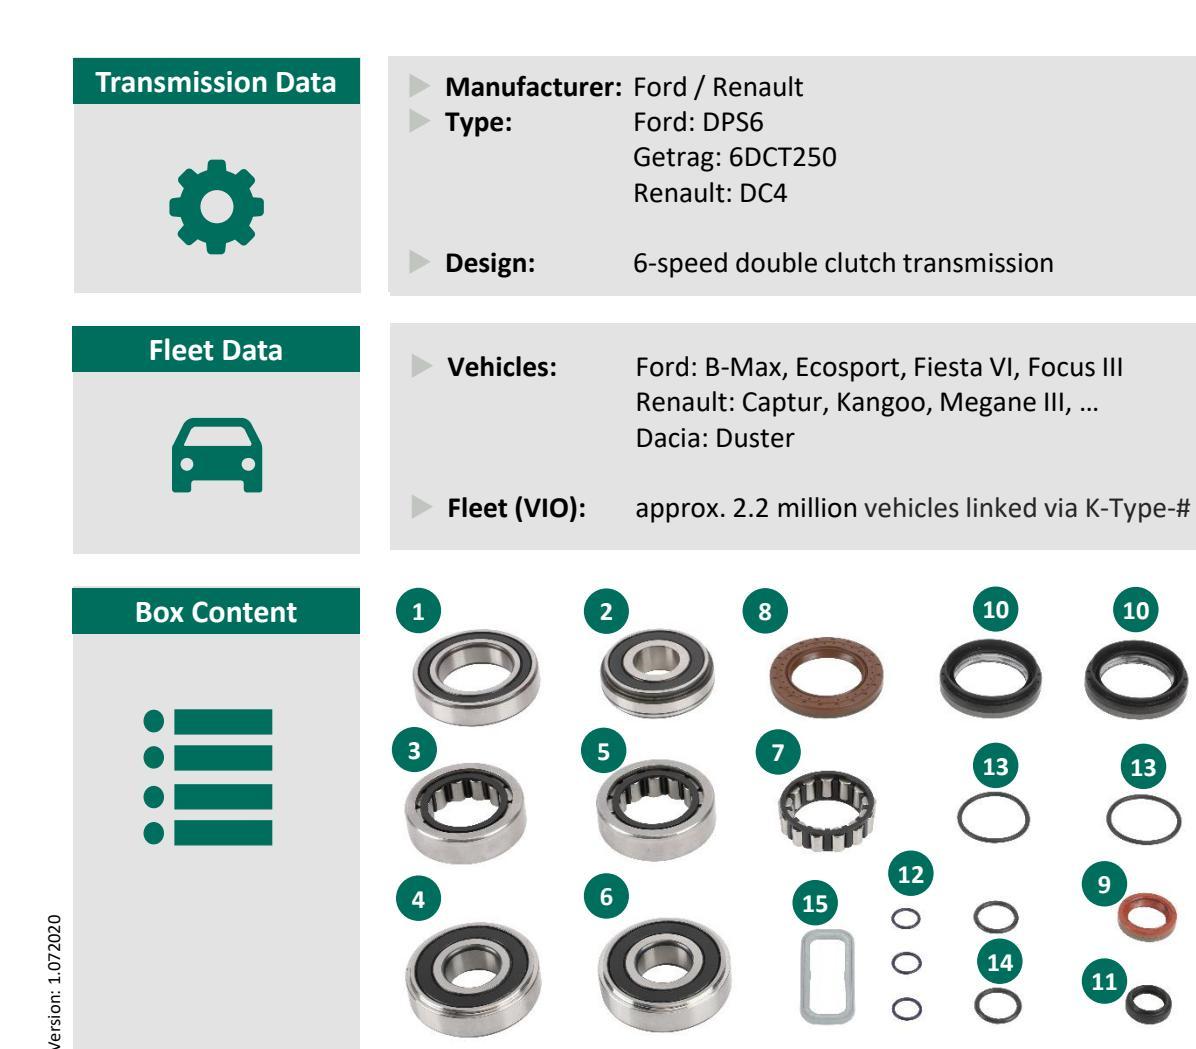
No.	Description	Mounting Position	Part	Dimensions (mm)
1	Main bearing input shaft	Engine side	Ball bearing	40.00 x 68.00 x 15.00
2	Main bearing input shaft	Gearbox side	Ball bearing	25.00 x 62.00 x 17.00
3	Main bearing output shaft 1	Engine side	Roller bearing	35.50 x 60.00 x 17.50
4	Main bearing output shaft 1	Gearbox side	Ball bearing	25.00 x 62.00 x 17.00
5	Main bearing output shaft 2	Engine side	Roller bearing	35.50 x 60.00 x 17.50
6	Main bearing output shaft 2	Gearbox side	Ball bearing	25.00 x 62.00 x 17.00
7	Support bearing input shaft	Inside	Roller bearing	34.00 x 49.00 x 17.00
8	Seal ring input shaft	Outside	Shaft sealing ring	
9	Seal ring input shaft	Inside	Shaft sealing ring	
10	Seal rings differential	Engine- / Gearbox side	Shaft sealing rings	
11	Seal ring lever parking lock		Shaft sealing ring	
12	Seal rings sensors		O-ring	
13	Seal rings mechatronics		O-ring	
14	Seal rings oil drain / -filler plug		O-ring

15	Seal switch parking lock		Flat gasket

- The main reason for failure of the Getrag 6DCT250 gearbox, usually at a high mileage, is wear of the main bearings.
- This repair solution relates to 6DCT250 transmissions from year of construction mid-2011 with changes in the retaining plates and main bearings of the output shafts. The new bearings have a 2.2 mm heel on the outer ring.
- Repair instructions are available from the vehicle manufacturer.
- Special tool (400 0477 10) for disassembly and assembly of the transmission as well as special tool for the double clutch (400 0427 10) available.
