MEYLE-HD: Better than OE. 3-in-1 control arm design

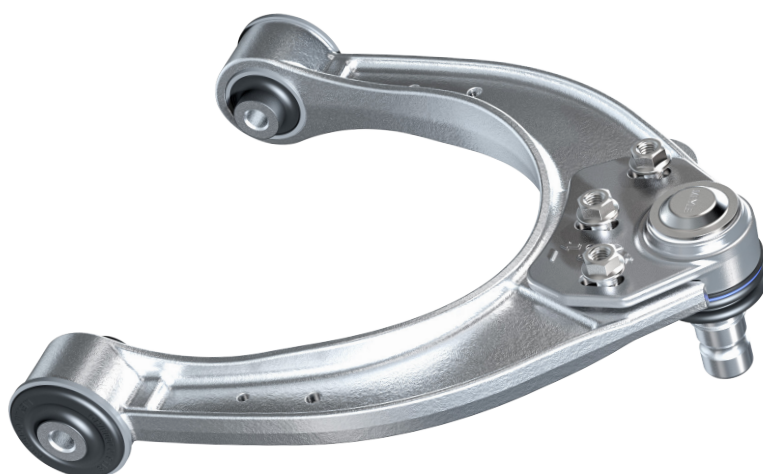
1 control arm to replace 3 OE equivalents

- Variable guiding suspension ball joint with clear position marking allows easy camber correction
- Replaceable MEYLE-HD ball joint
- MEYLE high-tech grease inside

- Only available from MEYLE: 3-in-1 solution covers all 3 OE control arms
- Saves time and money, warehousing space and simplifies logistics
- Longer life time
- 4-year warranty

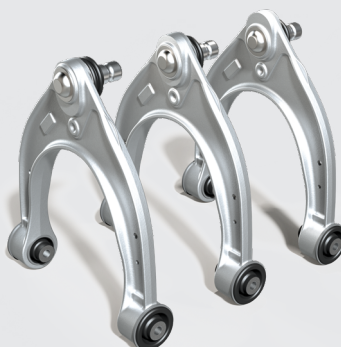
3 OE control arm versions

- Wear out of ball joints and rubber bushings due to high vehicle weight and strain to components
- OE part with correct chamber can only be identified during time intensive wheel alignment check before installation
