Engineered to perform, guaranteed to last

MEYLE-HD ball joints for the Renault Trafic III and Renault Master II

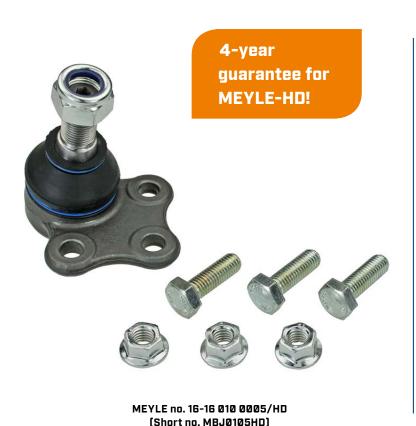
MEYLE no. 616 010 0005/HD (Short no. MBJ0271HD)

- Use of extremely wear-resistant plastic socket in the ball joint
- Constant lubrication film between the ball pin and plastic socket
- · High-strength self-locking nut
- MEYLE high-tech grease field-tested in shipbuilding and wind energy R&D
- High-quality rubber sleeve featuring a blue clamp ring

Continuously heavy axle loads are a frequent cause of early ball joint failure on Renault vans: Suffering from undersizing, original parts tend to fail quickly under the demanding operating conditions. Technically refined MEYLE-HD ball joints for Renault vans excel through the following product features:
