A complete solution for Ford Mondeo I+2!

Due to a change of design of the anti roll bar mounting by the car manufacturer, problems occurred when fitting the stabilizer mounting (SWAG 50 92 1855).

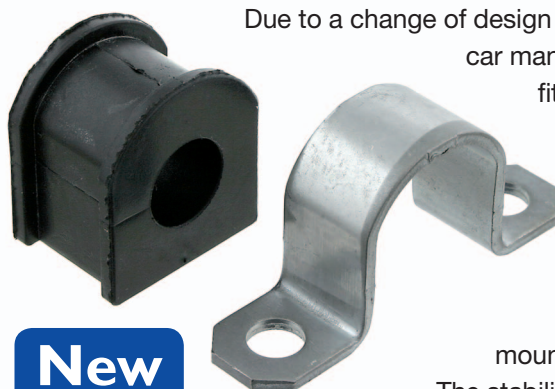
The former semi-circular design has now been changed to a flat design identical to the original part (see picture 3). This means the mounting clamp must also be changed.

The stabilizer mounts and clamps (SWAG 50 92 7355) should always be replaced in pairs to ensure a professional level of servicing.

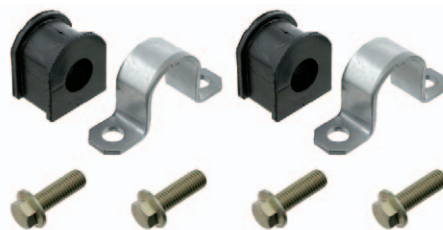
repair kit SWAG 50 92 7400

Stabilizer mounting repair kit (with clamps) SWAG 50 92 7400

This repair kit contains stabilizer mounts with matching mounting clamps as well as the required high tensile mounting screws (10.9 grade).
