## DONNEES TECHNIQUES

### BULLETIN TECHNIQUE TB-06

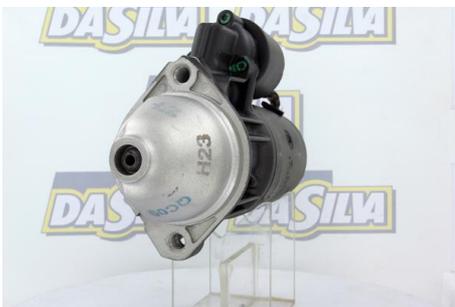
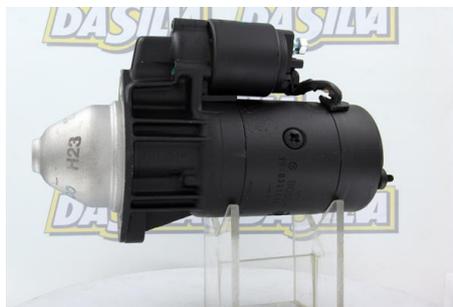
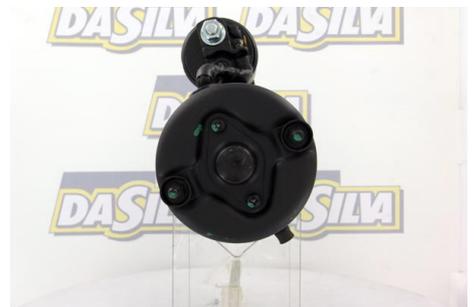
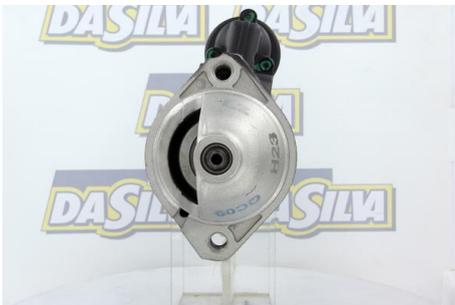
Ce démarreur est susceptible de rester « collé », (pignon / volant moteur) provoquant sa destruction complète ( centrifugage, brûlure complète, éclatement). Contrôlez la vieille matière au niveau de l'usure du pignon (voir dessin). La cause de ce problème est souvent due à un défaut de la clé de contact, à un problème de manque de courant et/ou au relais qui reste collé. Contrôlez et remplacez celui-ci en cas de doute.

This startermotor is prone to being held in mesh with the engine running, causing it to burn out. Check the old unit removed for piston damage (see picture). The causing of this problem is often caused by a sticking ignition switch or a sticking relay, replace if in doubt!
