AUTOELECTRO

STARTER MOTORS & ALTERNATORS

IMPORTANT PLEASE READ THE INFORMATION BELOW BEFORE FITTING THIS PART AS THERE ARE KNOWN ISSUES WHICH WILL RESULT IN THE PREMATURE FAILURE OF THE UNIT AND MAY INVALIDATE YOUR WARRANTY

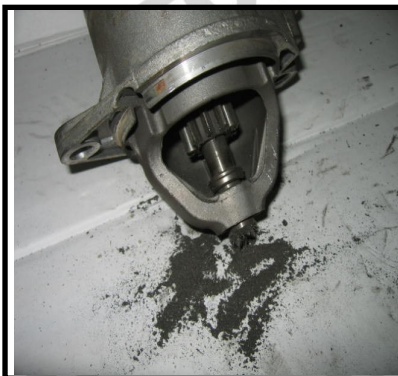
Look out for fluid residue, rust build up, distinctive smell and possible burning smell.

Signs of grey/metal dust can indicate that failure of the starter motor has been caused due to a failing Dual Mass Flywheel.

This dust can cause the bearing and gear shaft to become dry which results in the starter motor being noisy during operation and/or the pinion to stick on the gear shaft. In extreme circumstances the dust can stick to the magnets inside the starter motor and result in the starter motor exploding. Failure caused by dual mass flywheel is not a manufacturing defect and will **not** be covered under warranty.

It is critical that you visit our website to obtain information and carry out further investigations to locate the leak and rectify it prior to fitting the replacement unit. Failure to do so will cause the replacement unit to fail prematurely and will invalidate your warranty.
